### **Members of the Committee:**

## 1. BACKDROP:

Bellandur and Varthur lakes are the two largest lakes, of Koramangala & Challaghatta Valley in Bangalore that have been receiving the largest amount of wastewater. During the pre-monsoon of 2015, due to high wind coupled with rainfall, massive froth and aerosol formation was noticed in the southern waste weir of Bellandur lake eventually overflowing onto the neighbouring road obstructing traffic (**Figure 1**).

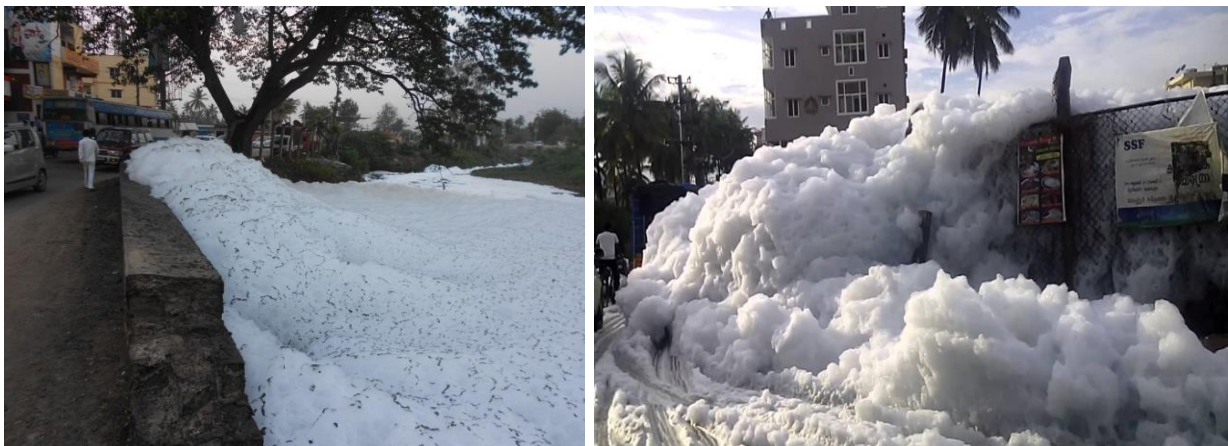
**Figure 1: Froth at the waste weir of Bellandur lake**

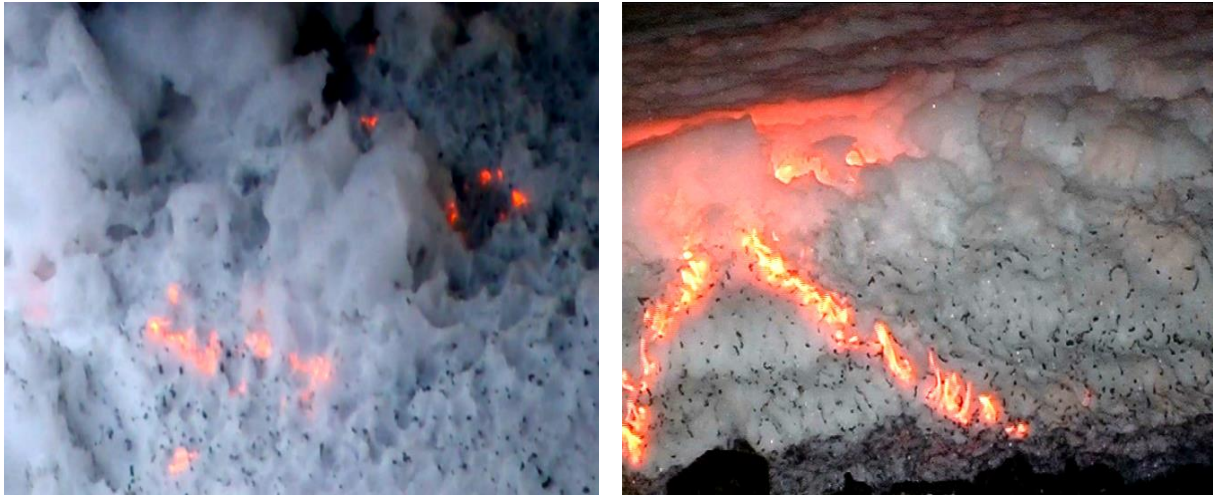
To make things worse, on **May 16, 2015**, the froth at the northern waste weir (Yamalur weir) of Bellandur lake caught fire and this created fear and anxiety in the minds of the people living in that region, leading to a major public outcry (**Figure 2**).

**Figure 2. Fire in the froth at Bellandur lake**

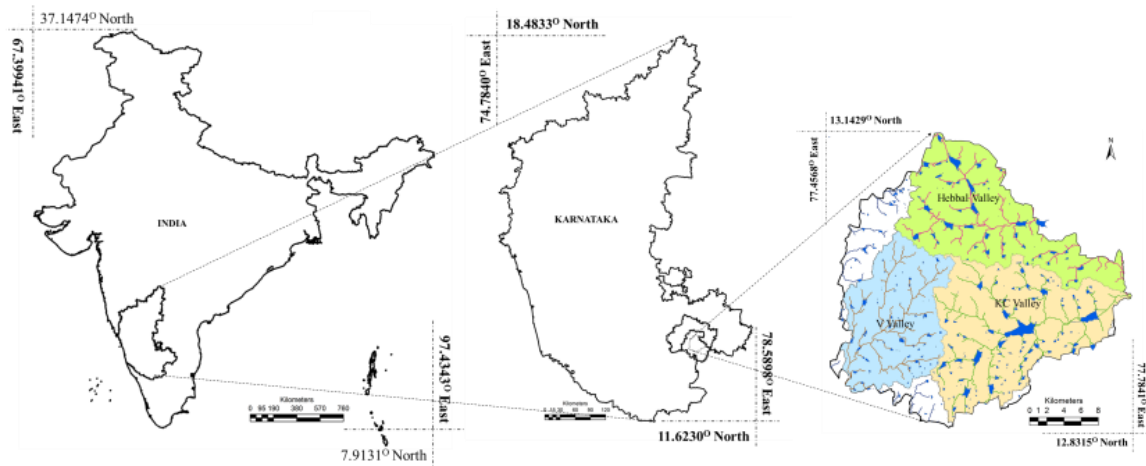
Bellandur and Varthur lakes are located in the south-eastern portion of Bangalore metropolitan region (**Figure 3**) with spatial extent of 370 hectares and 180 hectares respectively. Catchment of these lakes (**Figure 4**) ranges from 158.5 sq.km. to 279. sq.km.

**Figure 3: Interconnected Lake systems in Bruhat Bangalore**
